September, 2014

Addressing Stud Sheering Problems on Late Model GM Applications

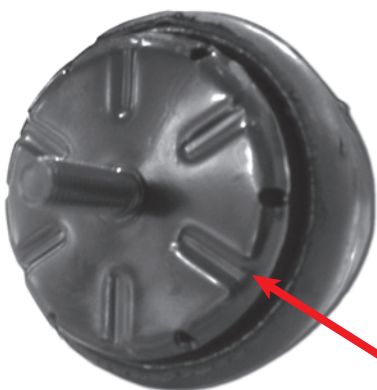
2897 TRANSMISSION MOUNT STUD SHEERING PROBLEMS

Anchor transmission mount #**2897** fits 2000-2005 Buick, Pontiac and Oldsmobile vehicles with the 3.8L engine. The 2897 mount has grooves on the bottom metal mounting plate and needs to be aligned with the notches on the vehicle's frame. If not properly aligned, the torque from the engine can twist the mount out of position and shear off the stud, resulting in a loud clunking noise and increased drivetrain vibration.

During installation, carefully inspect the position of the mount's recessed slots at the bottom of the mounting plate to make sure of proper alignment with the notches on the vehicle's frame. This will help eliminate sheering of the mount stud.

Note: It is also important to not over torque the transmission mount bolt. The proper torque specification for this application is 52 ft. lbs.

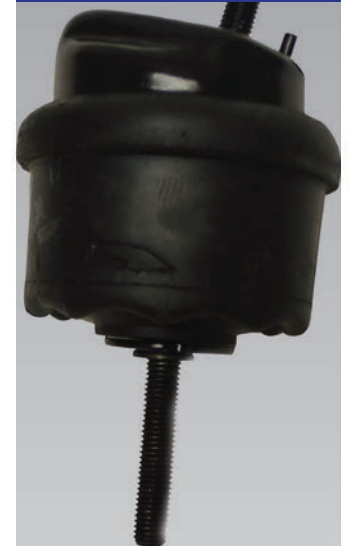
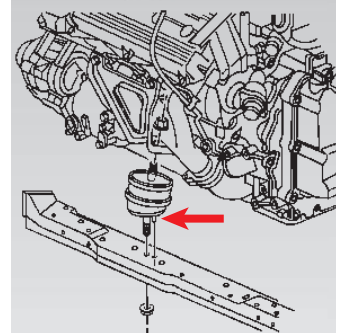
ANCHOR NO. 3020

GM has issued a Tech Service Bulletin (TSB 05-08-61-007A) regarding a clunking noise from the front of the vehicle while driving and/or shifting on a 2000-2005 Cadillac Deville and 2001-2003 Oldsmobile Aurora with the 4.6L engine. This bulletin supersedes TSB 05-08-61-007 and applies to Anchor transmission mount # 3020.

These vehicles may exhibit a clunking noise from the front of the vehicle while driving and/or shifting from Park to Drive, from Park to Reverse, from Drive to Reverse or from Reverse to Drive. This condition is often caused by a deteriorating mount due to high heat from the engine manifold or if the mount was not properly aligned during installation.

Inspect the mount for signs of wear, compression and aging. Check to see if the mount alignment tab is properly seated in the provided hole of the chassis.

- Make sure the **mount alignment tab** is correctly seated.
- Install a new heat shield if needed (OEM # 15804790)
