## DL512299 Technical Bulletin

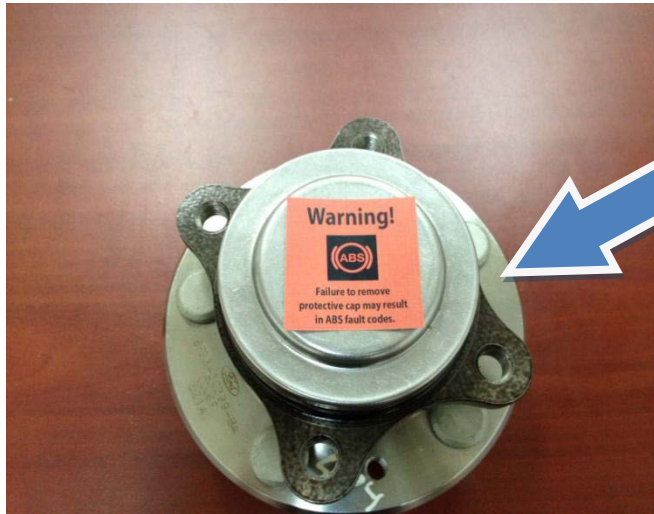
Failure to remove the protective shipping cap currently supplied with DL512299 may result in an ABS warning light being triggered.

*The cap creates interference within the magnetic pick up coil setting a fault code.*

Protective cover installed.
