Technical Bulletin: FA2098 Ball Joint Inspection

December 2012

Duralast Part No. FA2098 Press-In Ball Joint Inspection

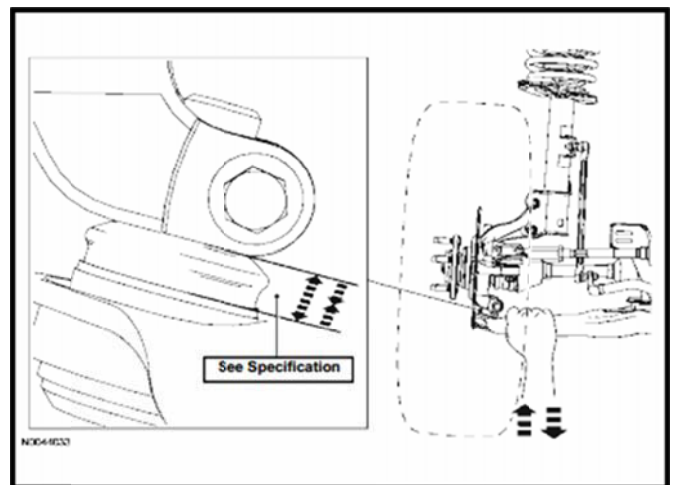
Description: This platform employs a spring-loaded ball joint, by OE design and subsequently aftermarket design(s). This means the ball stud can be compressed within the housing of the joint when new (by overcoming the resistance of the spring).

Technicians / Customers that are not aware of this design can misinterpret any vertical movement as wear. This ball joint is allowed a radial displacement of up to .032", or .813mm in metric. Measurement is taken between lower control arm and steering knuckle.

Complaint: Some customers suspect premature wear in ball joint due to radial "play" in the housing of the ball joint. Complaints may reference early wear shortly after installation.

If procedures are not followed correctly, it is possible to get a false measurement resulting in unnecessary part replacement.

1. Prior to checking for ball joint deflection, inspect for wheel bearing "play" and correct as necessary.
2. To minimize the error in the measurement the dial indicator should be aligned as close as possible to the ball joint centerline.
3. ***Use Hand Force Only.** The use of tools or equipment can cause damage and relative movement that may not exist when using hand force only.

Part is allowed .032 inches / .8mm deflection (movement) using hand force only.
