## Attention !

**Ford, Lincoln, Mercury and Mazda owners.**

To reduce the risk of premature starter failure these steps must be followed.

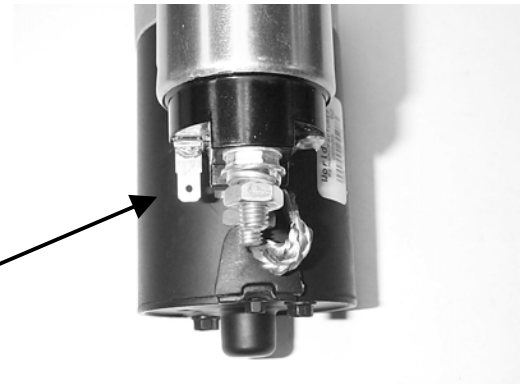
Applications equipped with Motorcraft style PMGR starters have a no start problem that usually occurs because of a bad ground or due to corrosion at the ignition terminal of the starter solenoid. Your starter was originally equipped with a male spade type of connector which is not protected from the elements thus creating corrosion and a poor connection.
