POSSIBLE SHORT CIRCUIT OF METALLIC WRAP

2000 CAMARO/FIREBIRD 5.7 LITER ENGINE (VIN G-RPO LS1)

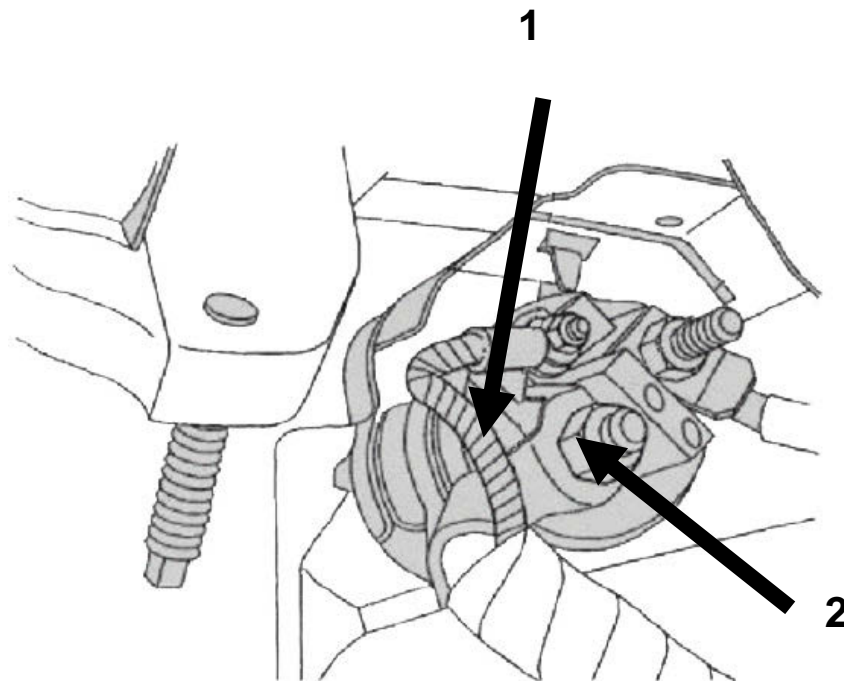
Make sure the metallic insulation wrap around the battery and solenoid wires (1) is intact and has no signs of fraying or splitting.

The wrap is conductive and improper routing of the solenoid wire near the battery terminal (2) could cause arcing between the terminals.

When connections are made to the starter motor, they must be positioned exactly as removed.
