POOR CONNECTION

1997-1998

BUICK SKYLARK

**CHEVROLET CAVALIER, MALIBU
OLDSMOBILE ACHIEVA, CUTLASS
PONTIAC GRAND AM, SUNFIRE
2.2L, 2.4L, 3.1L ENGINES**

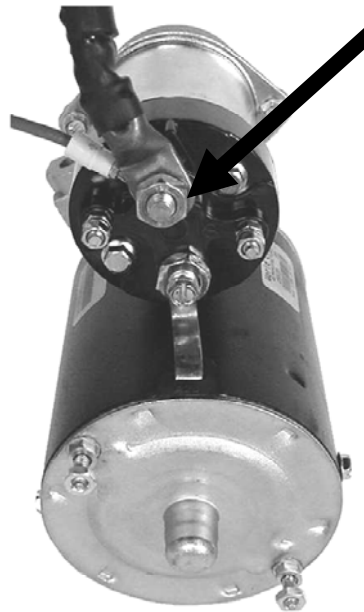
POTENTIAL FOR
PROBLEM AT
THIS AREA

According to General Motors, some owners have reported weak or discharged batteries; the starter motor may turn over slow, the alternator may not charge, and the malfunction indicator light may be on or come on intermittently

The alternator output cable goes to the starter “B+” and **then** to the battery positive. According to General Motors the “B+” stud at the starter **may** be loose, causing high resistance in the battery positive circuit from the alternator to the battery

Inspect the condition of the starter motor “B+” stud, wire, ring terminals, and nut. Clean each mating surface and replace all damaged parts. Tighten “B+” nut at starter to 106 in. lbs. (12N.m).
