Cranks over but has a hard start or no start

2003-2004 Ford Excursion, F-Super Duty Equipped with 6.0L and 7.3L Diesel

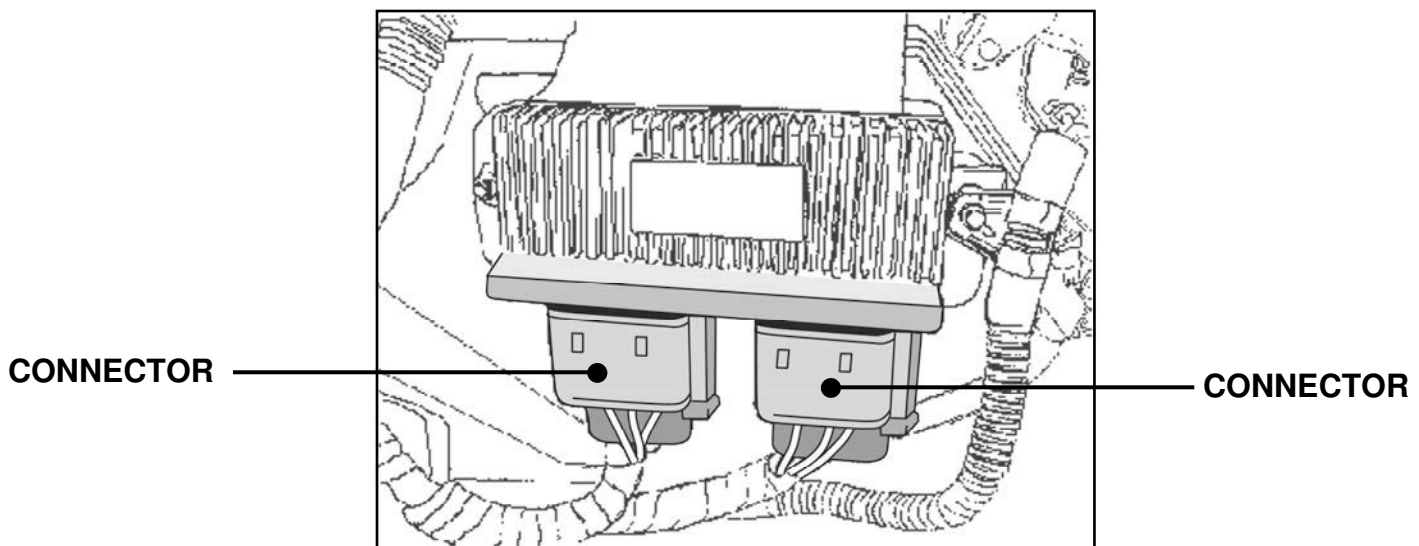
Some vehicles equipped with a 6.0L and 7.3L diesel may have this condition. This may be due to a Glow Plug Control Module **CONNECTOR**.

Glow Plug Control Module located right front engine

1. Make sure battery or batteries are fully charged
2. Inspect GPCM connector for:
 - Pin fit. No looseness
 - Pin pulled out
 - Bent pins
 - Corrosion / oxidation
3. If connector problems exist, replace connector with service kit from dealer. (GPCM Connector Kit: 4C32-12B568-AA)
4. If no connector problems present, proceed with normal diagnosis.
