NO CRANK, NO START

**2004 Buick Le Sabre, Park Avenue/Ultra
2004 Pontiac Bonneville
With 3.8L (Engine Vins 1, K)**

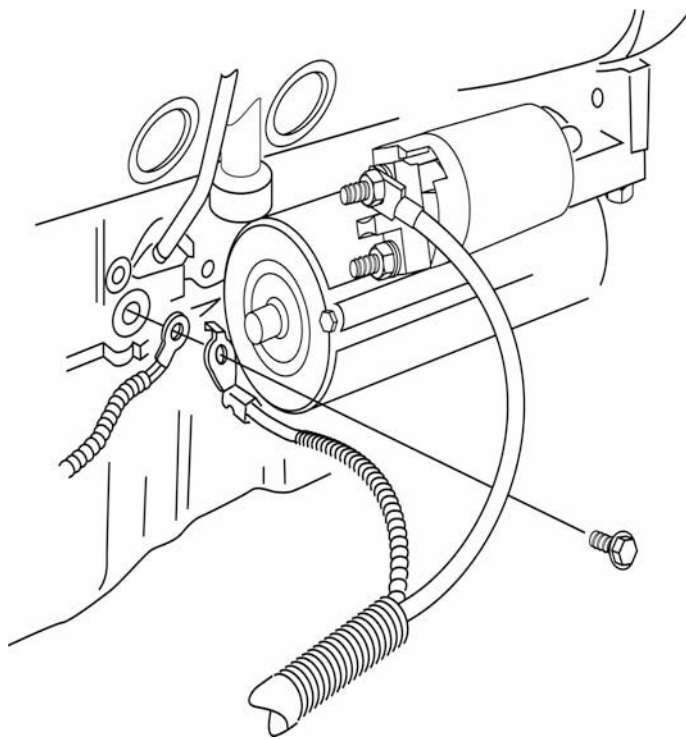
Condition: Intermittent no crank or no start.

Cause: Ground location on engine block may not be drilled or taped deep enough, preventing the bolt from achieving a proper ground connection. General Motors recommends using a shorter bolt to properly ground the harness connection. An additional option would be to place a flat or toothed washer between the bolt head and the negative battery cable. Final result is that the

ground cable must be firmly clamped against the engine block.
