Cranks over but has a hard start or no start

2003-2004 Ford Excursion, F-Super Duty Equipped with 6.0L and 7.3L Diesel

Repeated Starter Replacements

F Series 2002 – 2003 7.3L

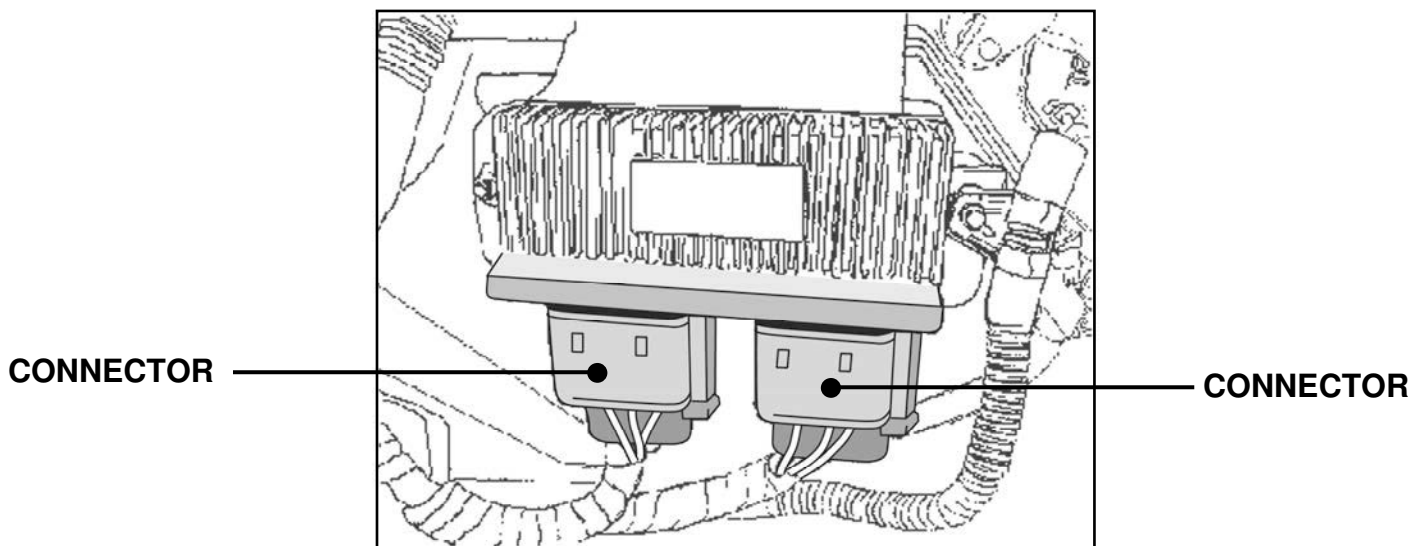
Some vehicles equipped with a 6.0L and 7.3L diesel may have this condition. This may be due to a Glow Plug Control Module **CONNECTOR**.

Glow Plug Control Module located right front engine

1. Make sure battery or batteries are fully charged
2. Inspect GPCM connector for:
 - Pin fit. No looseness
 - Pin pulled out
 - Bent pins
 - Corrosion / oxidation
3. If connector problems exist, replace connector with service kit from dealer. (GPCM Connector Kit: 4C32-12B568-AA)
4. If no connector problems present, proceed with normal diagnosis.

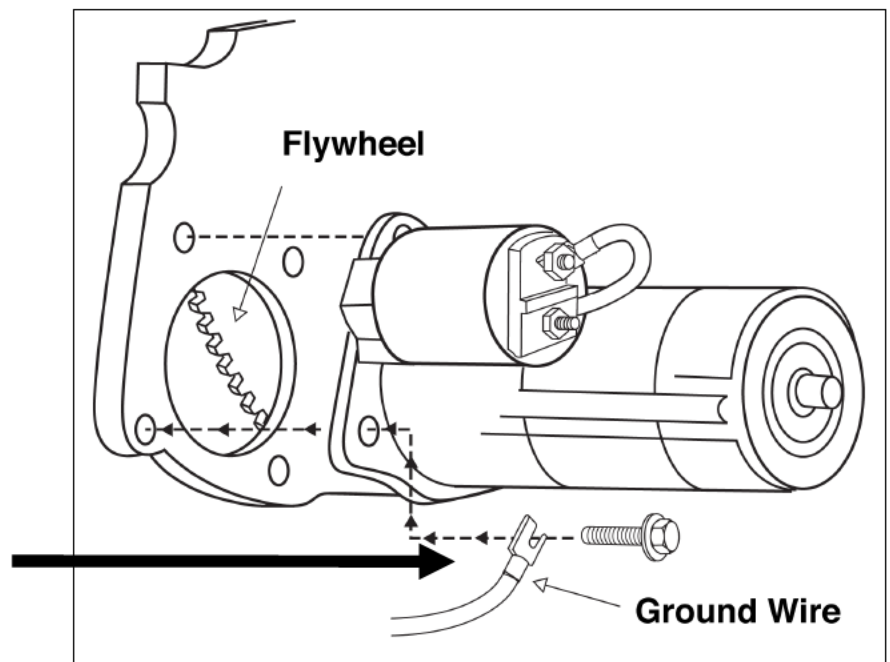
#1 Symptom: Repeat starter replacement, Starter motor spins without engagement, Starter motors spins then engages harshly, Slow cranking or No cranking.

Probable cause: Poor ground cables and connections

Solution: Clean and tighten current cables and connections. Adding a secondary ground 2/0 gauge cable/wire or heavier from the starter mounting bolt to the battery ground post or frame connection has resulted in improved starting capability and increased starter life.
