Alternator Not Charging / Battery Weak or Dead

1998 Chevrolet/GMC "S" and "T" series light trucks

1998 Oldsmobile Bravada

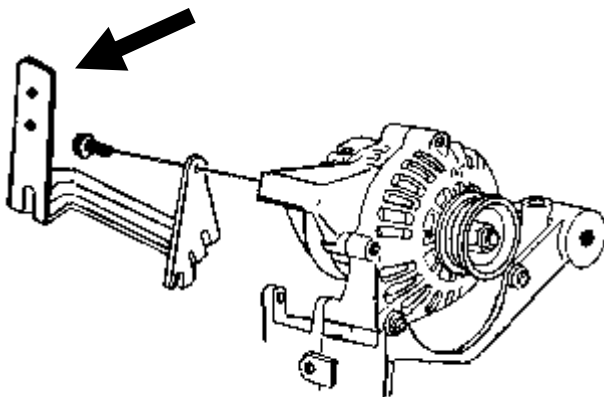
According to General Motors, if your alternator is not charging it may be due to the "L" terminal wire being cut or chafed within a few inches of the four-pin connector at the rear of the alternator. This is being caused by the harness conduit and wire rubbing against a sheetmetal bracket used to support the heater hoses, which are fastened to the rear of the alternator. (see illustration)

Area where damage may occur
Sheetmetal bracket

8. ROUTE THE WIRE . RESTRAIN THE WIRE FROM CONTACT WITH THE HEATER HOSE BRACKET.
