Multi Alternator Replacements and still OVER CHARGE OR NO CHARGE?

1995 to 1998 Buick Riviera
1995 to 1999 Olds Aurora
1987 to 1993 Cadillac Allante
1998-1999 Cadillac Seville

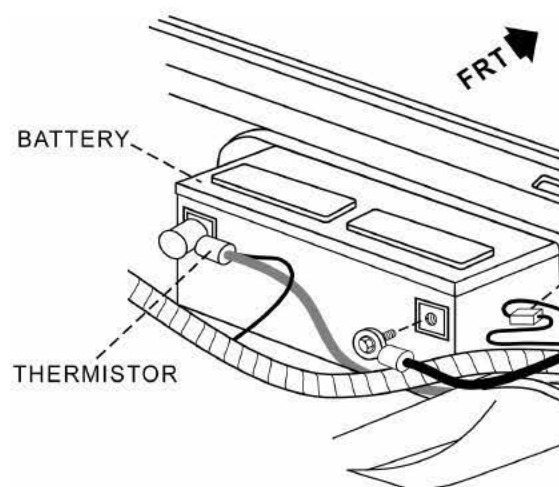
Constant overcharge or no charge problem. Charge Warning Lamp stays on.

Possible Cause: A defective Temperature Thermistor located at the positive battery cable.

The thermistor monitors the temperature at the battery and adjusts the alternator charge rate according to battery temperature variation. If defective, it miscommunicates to the alternator regulator, affecting its ability to charge correctly. The incorrect charge rate illuminates the Charge Warning Lamp.

Research has found that a replacement thermistor is no longer available.

The alternator provided has a regulator circuit redesign that will function properly with a defective thermistor.
