Duralast Bearing Facts

2005-1999 FORD F250, F350, F450 & F550, 4X4 Models

Front Wheel Hub Numbers:

DL515020, DL515021, DL515025, DL515056, DL515075,
DL515076, DL515077

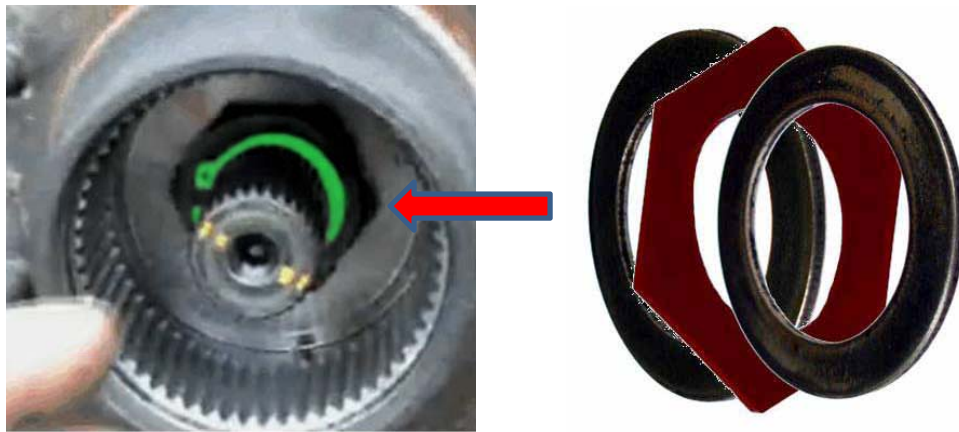
Assembling thrust washers incorrectly, may cause the non-metallic washer to fail prematurely, allowing the axle shaft lateral movement under torque, causing damage to the wheel hub and bearing.

Correct location of the non-metallic washer is centered between the two metallic washers.

Ensure the cir-clip is fully seated before inserting the actuator.
