# *Duralast* Bearing Facts

## 2005-1999 FORD F250, F350, F450 & F550, 4X4 Models

Front Wheel Hub Numbers:

DL515021, DL515025, DL515026, DL515027, DL515056,  
DL515075, DL515076, DL515077

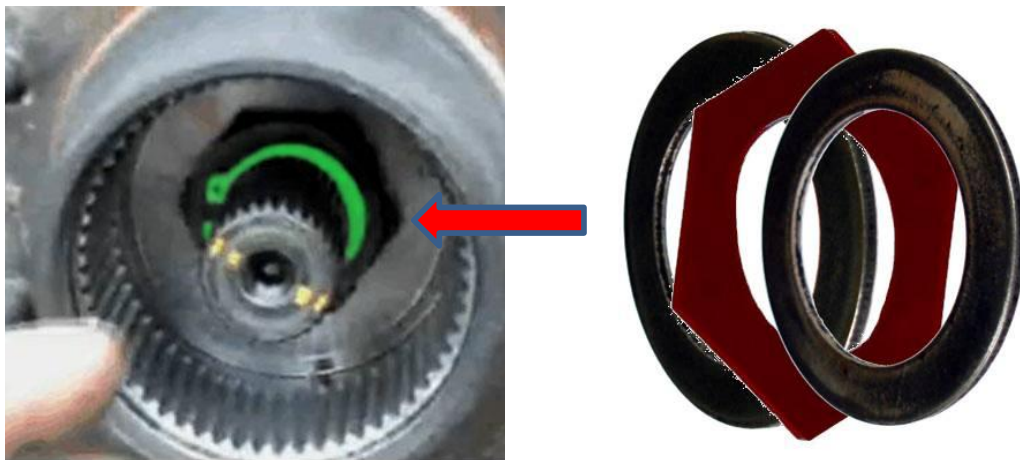
Assembling thrust washers incorrectly, may cause the non-metallic washer to fail prematurely, allowing the axle shaft lateral movement under torque, causing damage to the wheel hub and bearing.

Correct location of the non-metallic washer is centered between the two metallic washers.

Ensure the cir-clip is fully seated before inserting the actuator.
