# TECHNICAL TIP

### TT-116-6TB

### 1999-2000 Cadillac Escalade 1995-2000 Chevrolet and GMC SIT models 1996-2000 Chevrolet and GMC CIK, MIL, G, P models 1996-2000 Oldsmobile Brayada

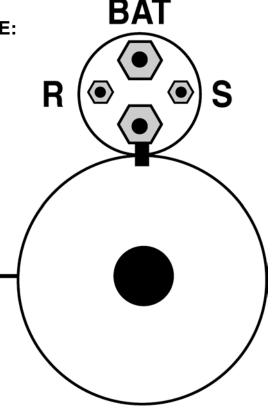
- Install starter and fasten all electrical connections securely.
- Connect a voltmeter to the starter in this manner. Black lead to starter case; red lead to "S" terminal. Attempt to crank engine.

In many cases the "R" terminal will not be used. This is normal.
