TB # 91006

VW '92-'05 Vehicles with Sanden SD7V16 Compressors

TRAPPING LEFTOVER DEBRIS IS CRITICAL

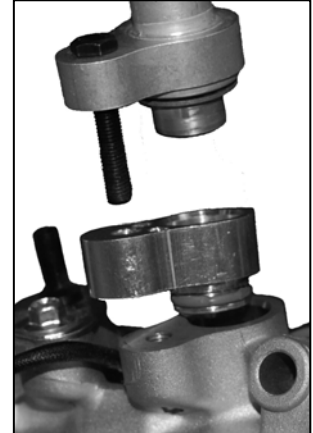
A failed compressor leaves metal shavings and debris in your a/c system that flushing cannot remove. This can cause poor cooling performance, noisy operation, and can lead to compressor failure.

Add a Compressor Guard Filter Plate (Part# 91006) with your replacement compressor installation to trap debris and ensure maximum service life for the new unit.
