# TECHNICAL TIP

### TT-116-6TB

### 1999-2000 Cadillac Escalade 1995-2000 Chevrolet and GMC SIT models 1996-2000 Chevrolet and GMC CIK, MIL, G, P models 1996-2000 Oldsmobile Brayada

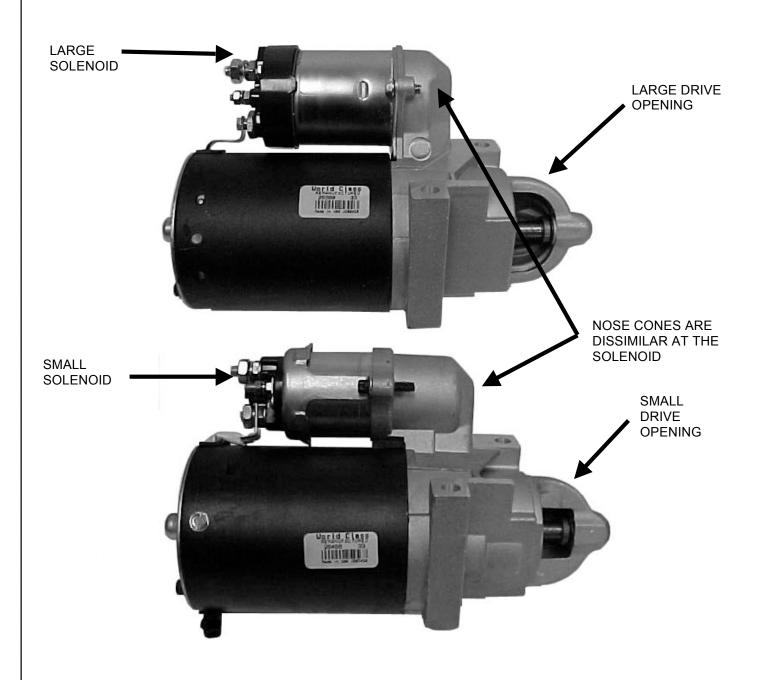
This part meets or exceeds the original manufactures specifications for correct vehicle application. Despite the differences in apperance, the units pictured below are interchangeable.
