Read This!

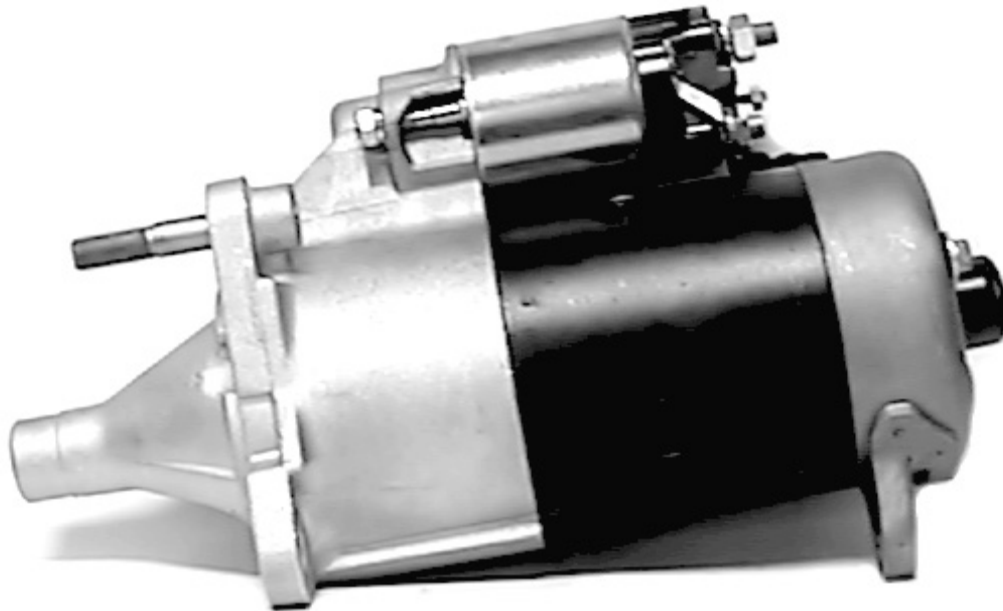
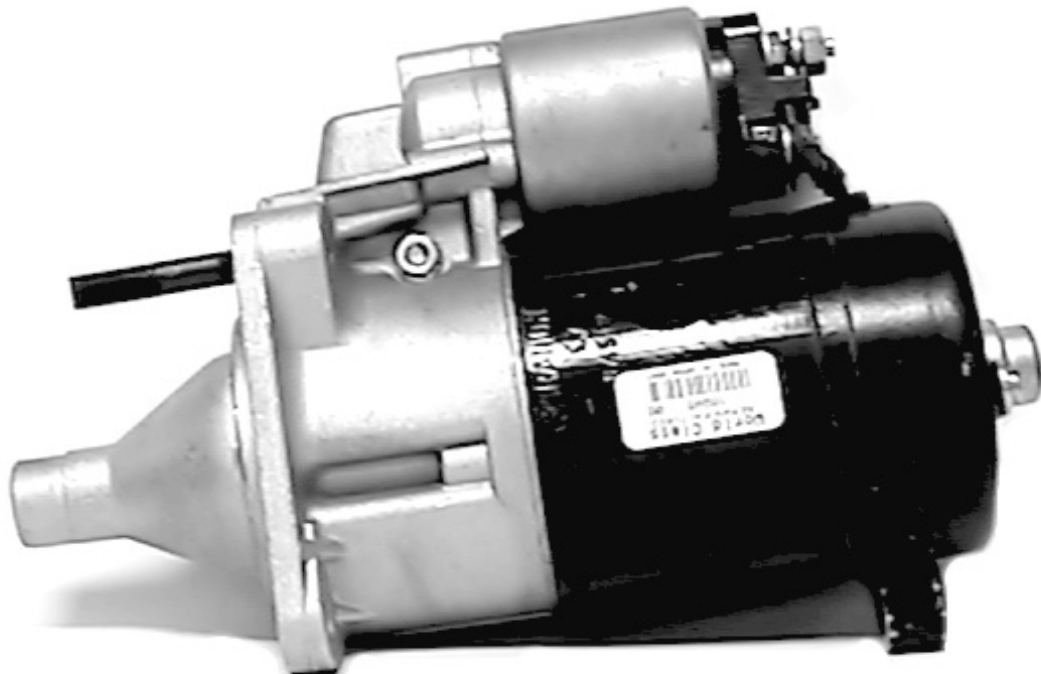
These units are interchangeable

Although the unit you purchased may not look exactly like the one removed from the vehicle, it will install and operate with no modifications necessary.
