TB # 91008

Ford, Ford Truck, Lincoln / Mercury '88-'03 with FS10 or FX15 Compressors

TRAPPING LEFTOVER DEBRIS IS CRITICAL

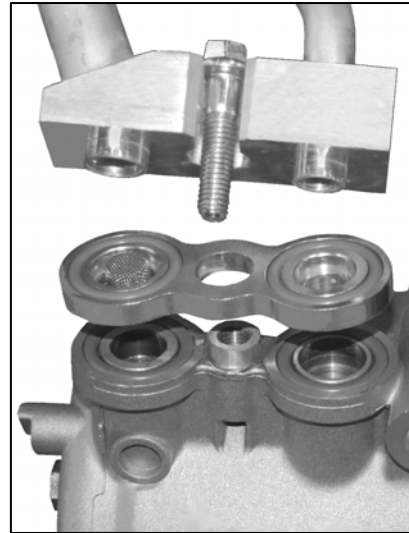
A failed compressor leaves metal shavings and debris in your a/c system that flushing cannot remove. This can cause poor cooling performance, noisy operation, and can lead to compressor failure.

Add a Compressor Guard Filter Plate (Part# 91008) with your replacement compressor installation to trap debris and ensure maximum service life for the new unit.
