Gabriel Technical Bulletin

G56514 Ultra Strut – Front Right

97-01 Lexus ES300; 97-04 Toyota Avalon; 97-01 Toyota Camry; 99-03 Toyota Solara

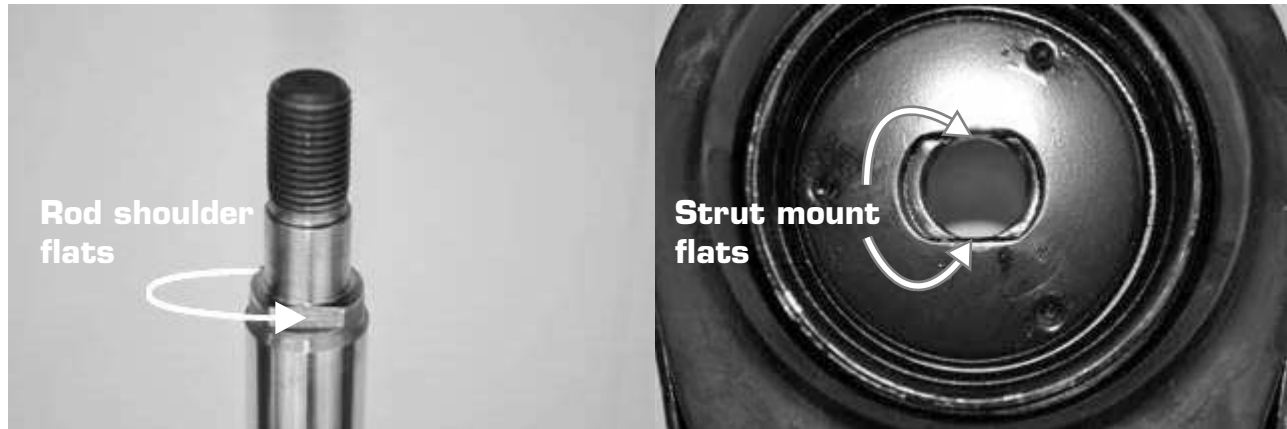
Representative - For illustrative purposes only

The upper strut rod shoulder has two flats that must align with corresponding flats formed in the mating surfaces of the strut mount. These parts must be interlocked by the flats so that the rod will not turn relative to the mount when tightening to achieve final torque. Failure to maintain this alignment may result in:

- Loosening of the fastened joint
- Development of noise due to a loose joint
- Eventual failure of the strut mount and/or strut

ReadyMount # G56931 is recommended as an alternative to Ultra Strut # G56514 to avoid servicing difficulties and assembly errors.
