## Gabriel Technical Bulletin

### **G55675 Ultra Strut – Rear Left**

97-01 Lexus ES300; 97-04 Toyota Avalon; 97-01 Toyota Camry; 99-03 Toyota Solara

### **Installation Difficulty is High**

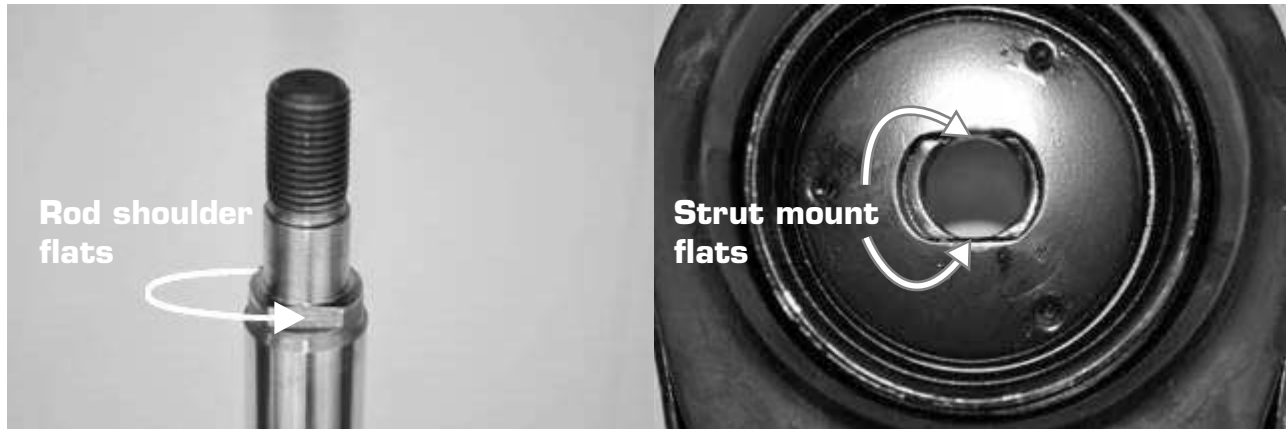
The upper strut rod shoulder has two flats that must align with corresponding flats formed in the mating surfaces of the strut mount. These parts must be interlocked by the flats so that the rod will not turn relative to the mount when tightening to achieve final torque. Failure to maintain this alignment may result in:

- Loosening of the fastened joint
- Development of noise due to a loose joint
- Eventual failure of the strut mount and/or strut

Representative - For illustrative purposes only

**ReadyMount # G56932 is recommended as an alternative to Ultra Strut # G55675 to avoid servicing difficulties and assembly errors.**
